NASA CR-165395

DEVELOPMENT OF IMPROVED HIGH TEMPERATURE COATINGS FOR IN-792 + Hf

D.D. Profant
S.K. Naik

CONTRACT NAS3-22371
FINAL REPORT
JUNE 1981

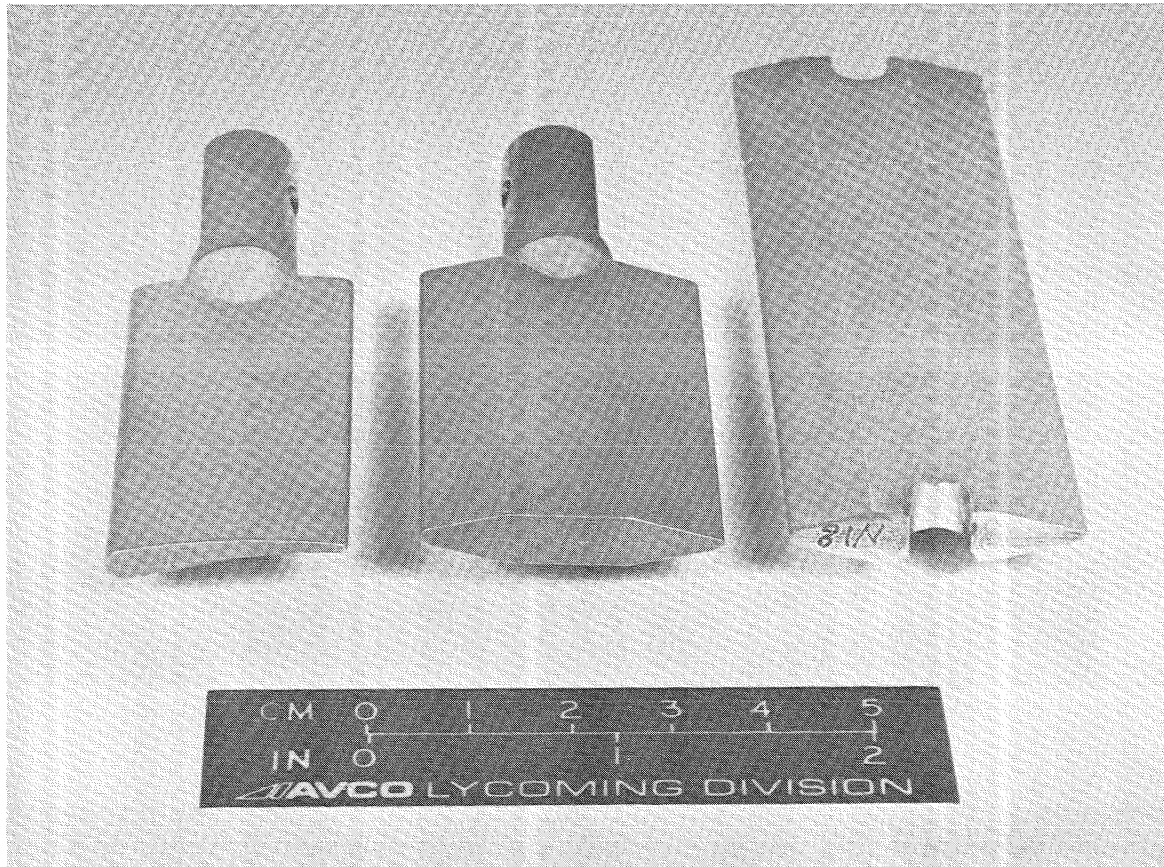
Figure 3 Cast Test Specimens L to R: Oxidation/Corrosion Airfoil Test Paddle, Lycoming Thermal Fatigue Wedge Bar, NASA/IITRI Thermal Fatigue Wedge Bar.

All specimens were cast by Jetshapes in accordance with standard Lycoming procedure for turbine blades. A photograph of the oxidation/corrosion airfoil test specimen, Lycoming modified thermal fatigue double wedge bar and the NASA/IITRI double wedge specimen is shown in Figure 3. Figure 4 shows the dimensions of each specimen.

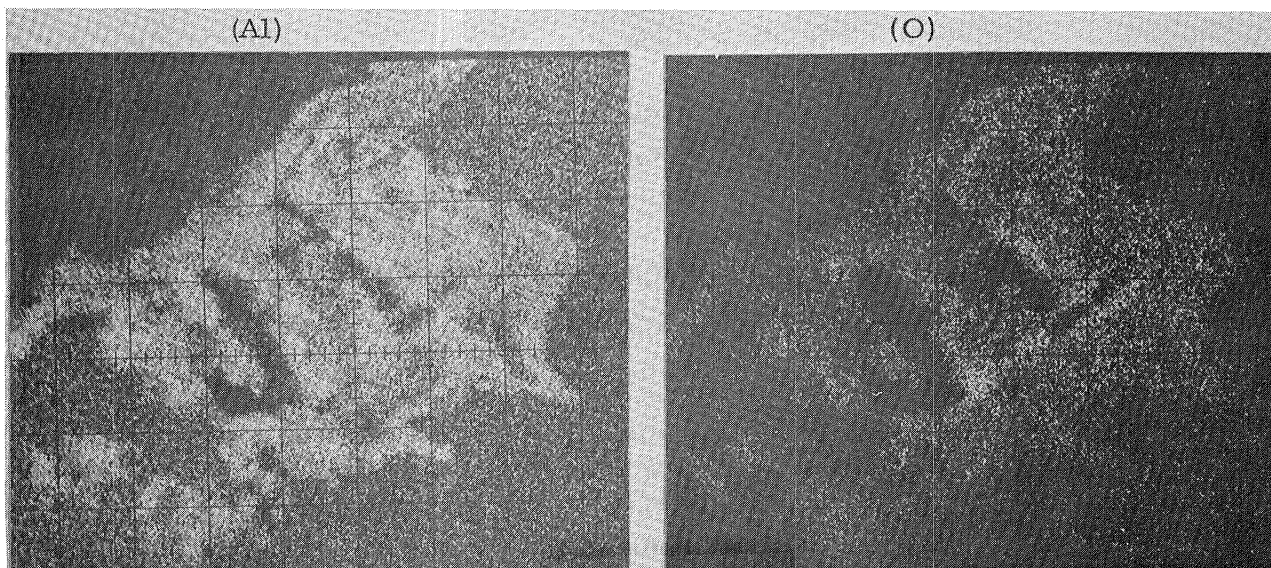
Figure 45

X-Ray Images Showing Distribution of Al, O in Failed Section of 701 Coating after 140 Hours (1325 Cycles) of Oxidation/Corrosion Test. (Figure 45 cont'd on next page).
